**PROPOSED WATER SUPPLY AUGMENTATION BOREHOLE FOR THE PROPOSED  
MALABAR SITE WITHIN THE NELSON MANDELA BAY MUNICIPALITY, EASTERN CAPE**

**TERRESTRIAL BIODIVERSITY ASSESSMENT**

20 March 2025

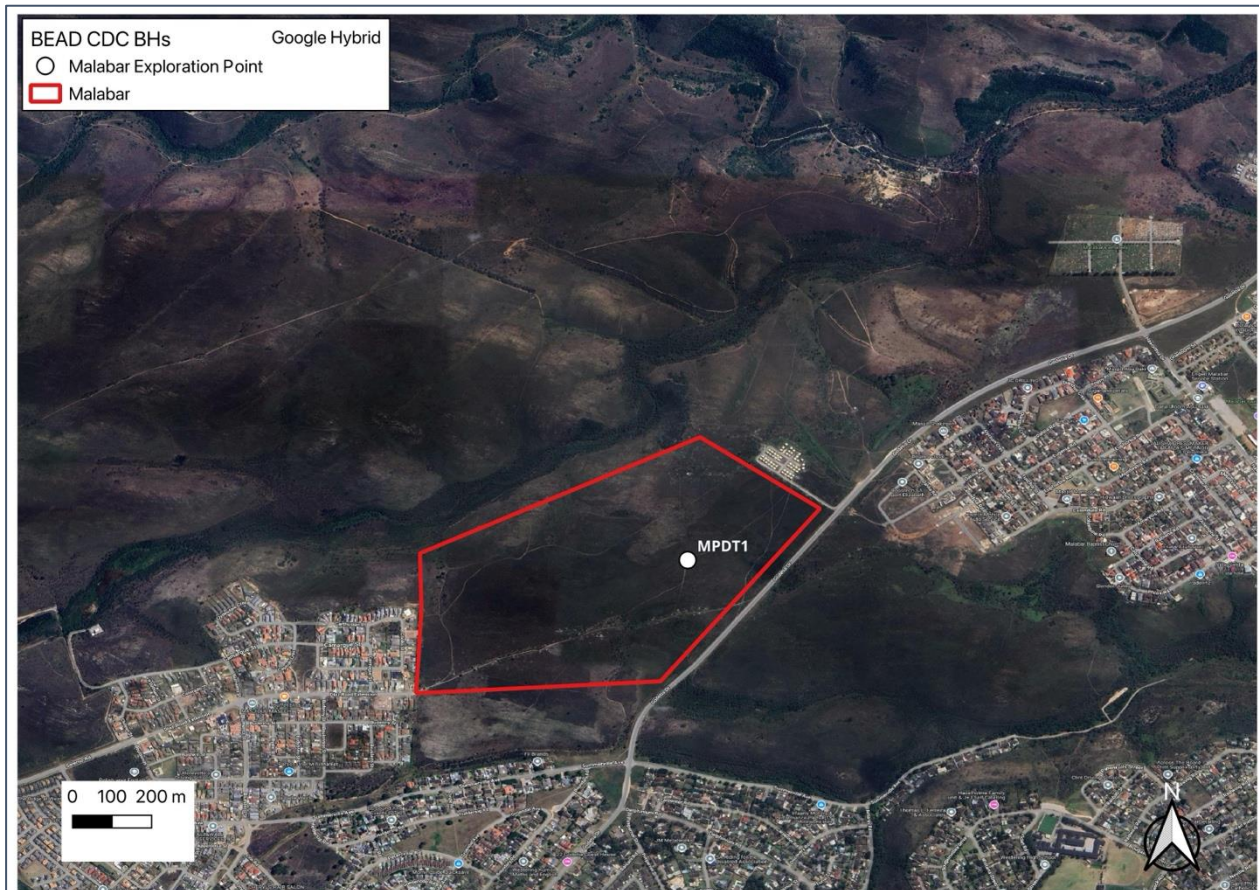
**Figure 1: The site boundary in relation to the surrounding environment and road infrastructure and the proposed exploration drilling site**

- Phase 1 is aimed at the exploratory activities only and some of the proposed exploratory boreholes could be located within 100 meters of watercourses within the Aspen Heights site (Figure 1).

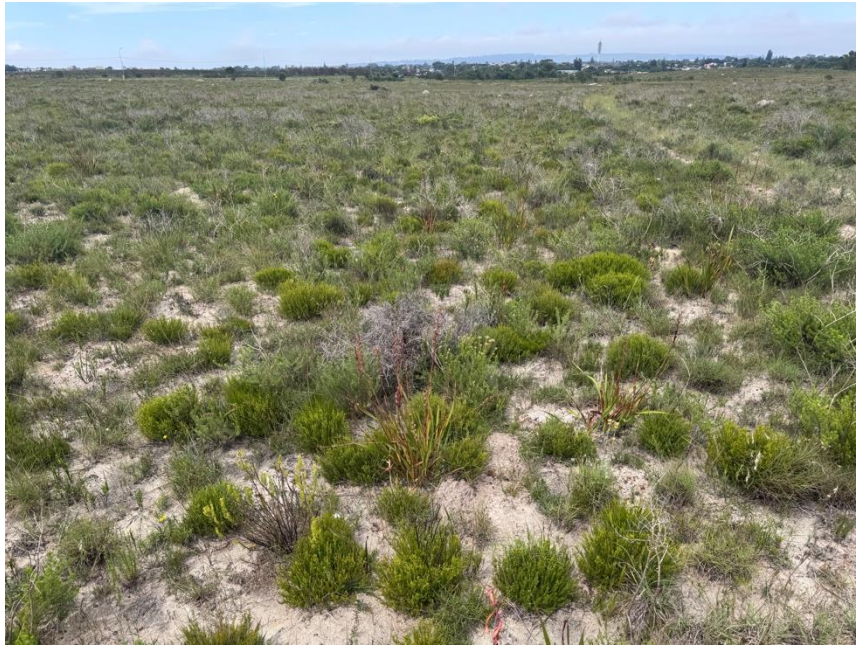
The proposed drilling site is located near an existing track, or rather at an intersection of tracks, which traverse varying degrees of intact vegetation (Plate 1 & 2).

**Plate 1: A view of the drilling site, dominated by *Bobartia* and *Watsonia* spp, with one of the access tracks in view**

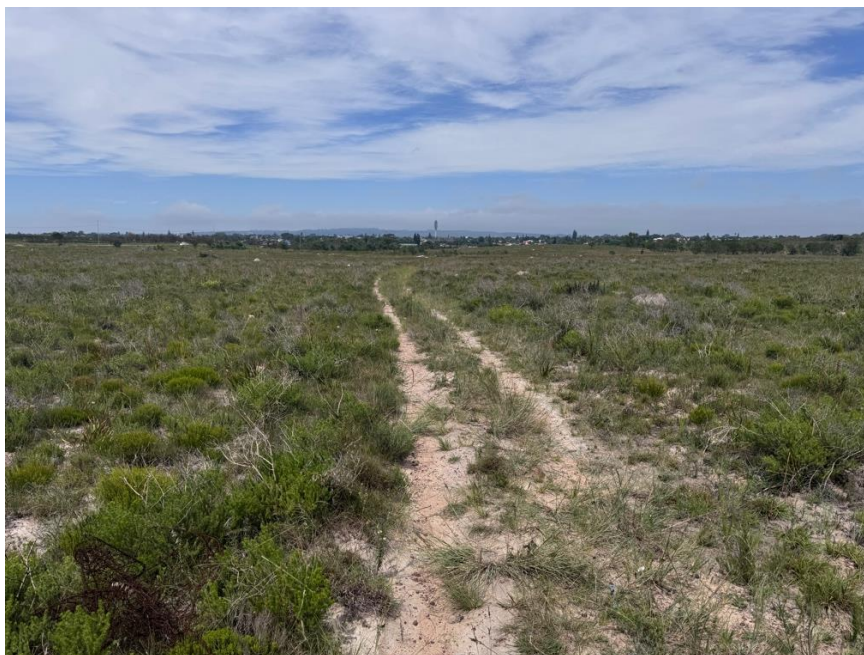
**Plate 2: The access track leading to the west, which is more disturbed thus minimising disturbance to reach the site**
