SITE SENSITIVITY VERIFICATION REPORT

PROPOSED TURNKEY BOREHOLE EXPLORATION AND DRILLING PROJECT IN THE NELSON MANDELA BAY MUNICIPALITY AREA (BEAD), EASTERN CAPE – MALABAR

April 2025

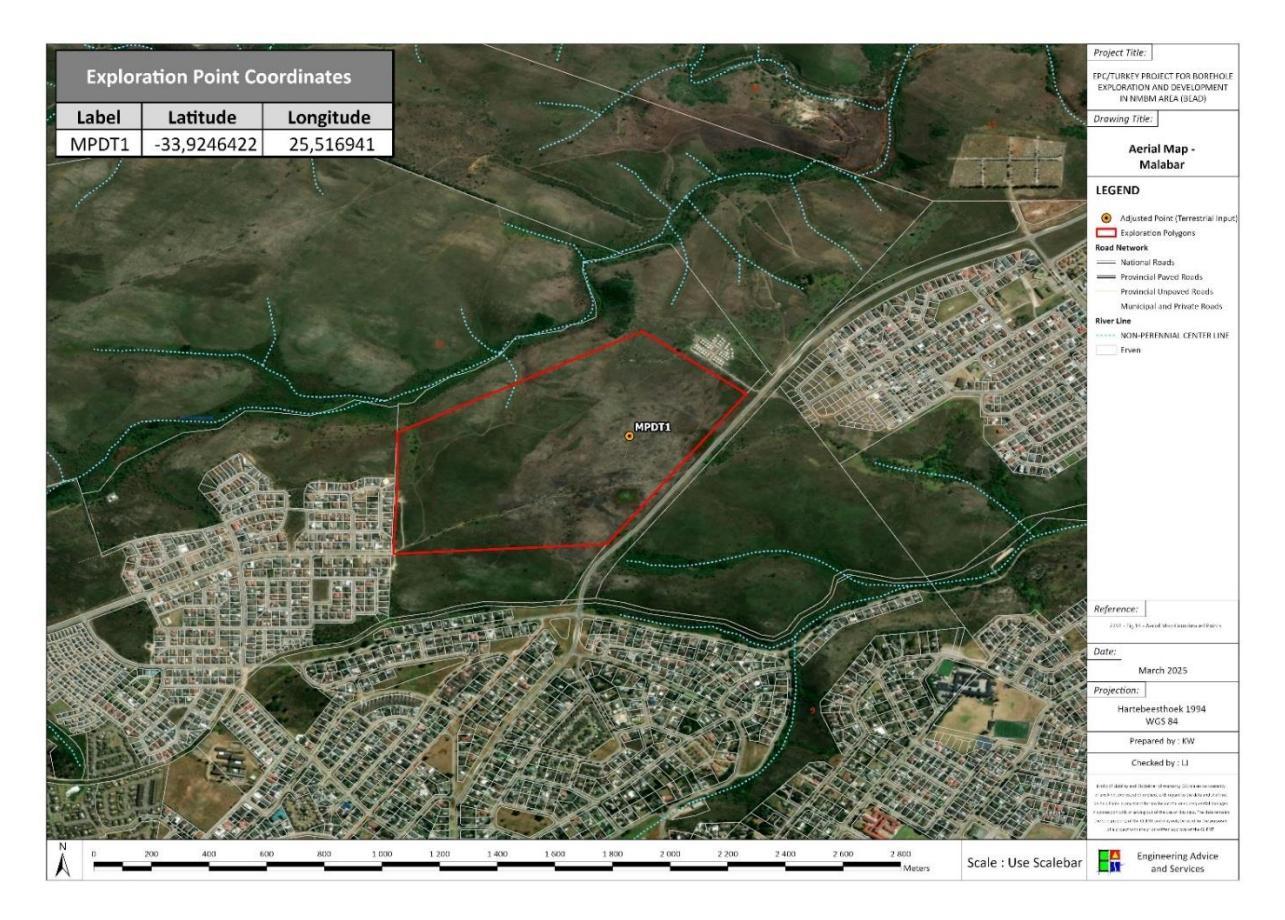
Figure 1. Explorations points in Malabar

Only one borehole site will be explored in Malabar. The terrestrial biodiversity specialist suggested that the Malabar exploration site be relocated 5m to the west (33°55'28.71" S 25°31'0.99" E), and only the access road shown in **Figure 2** be used due to the high degree of disturbance that already exists. The position of the borehole site is shown in **Figure 1**.

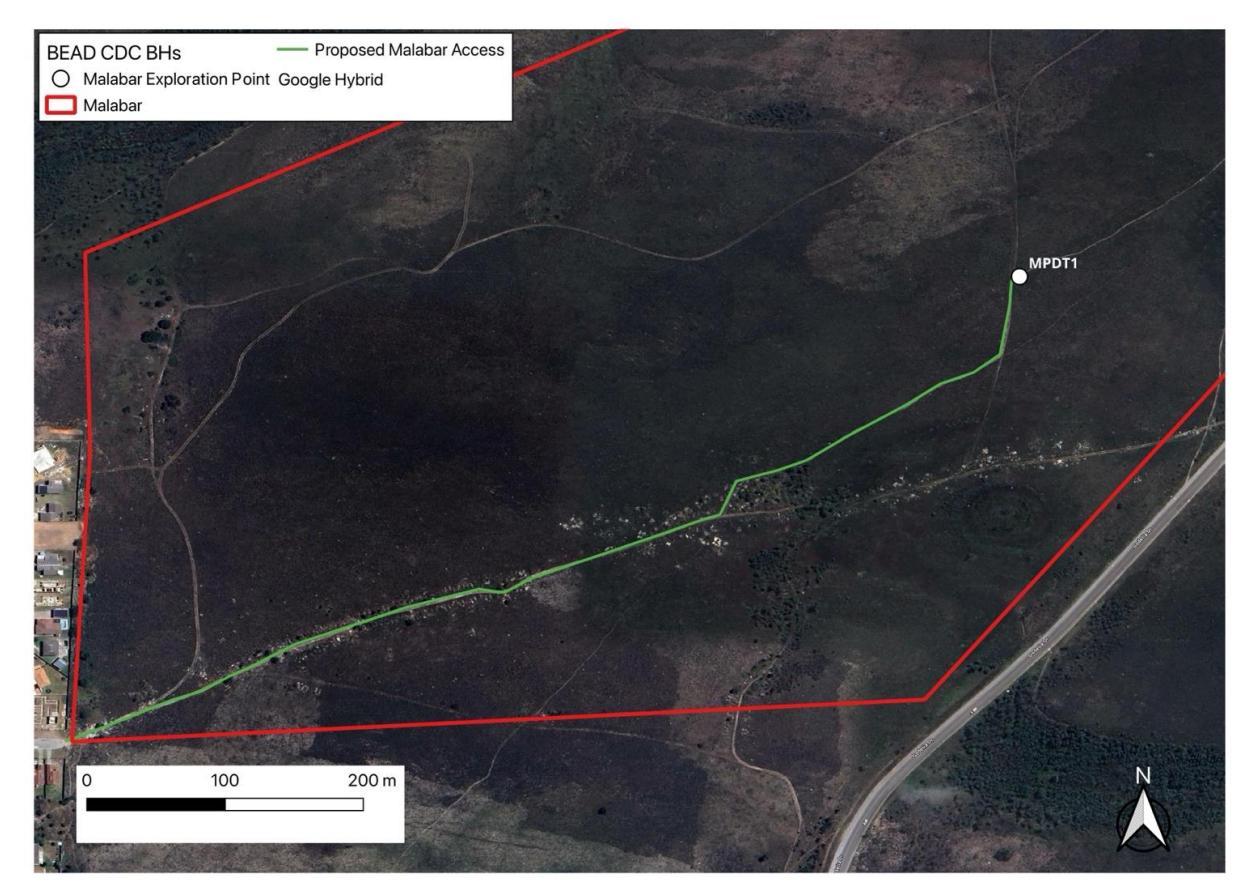
Figure 2. Proposed access route along existing track with a high degree of disturbance (illegal solid waste disposal)

Malabar is situated east of the city center of Gqeberha. This area is primarily residential. The proposed Malabar site is vacant and undeveloped. Illegal dumping of general waste and concrete rubble was observed on the site.

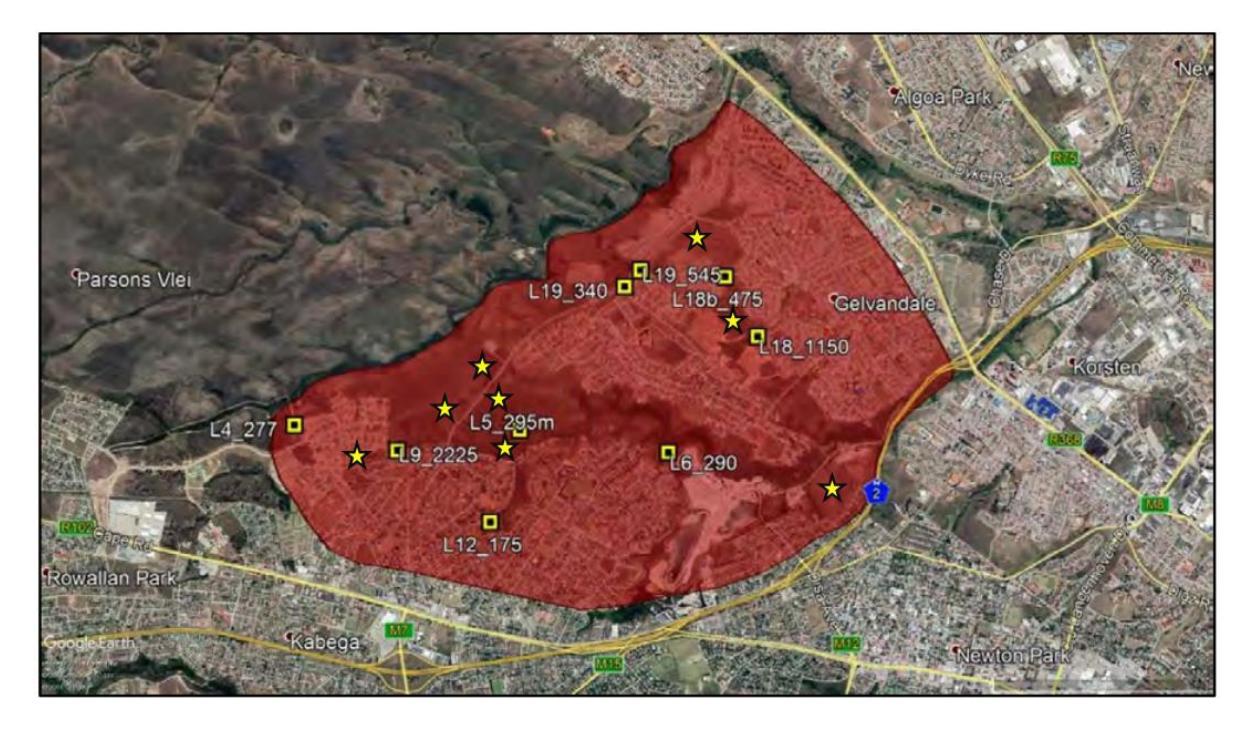
Figure 3. Current known distribution of Aspalathus sp. around the north-western suburbs of Port Elizabeth (red overlay) (Dr Grobler, 2019)

In 2019, Dr Grobler completed an assessment of nine sites along the Moregrove Fault Zone. The aim was to confirm the presence or absence of an undescribed *Aspalathus sp* at the borehole sites. The proposed Malabar site falls within the area that was assessed. Surveyed boreholes are indicated by yellow squares, while yellow stars indicate other sites where *Aspalathus sp*. was recorded. The species appears to occur throughout the grassy fynbos in the north-western areas of Port Elizabeth between Cotswold and Schauderville in the east and westward to at least Groot Kloof.

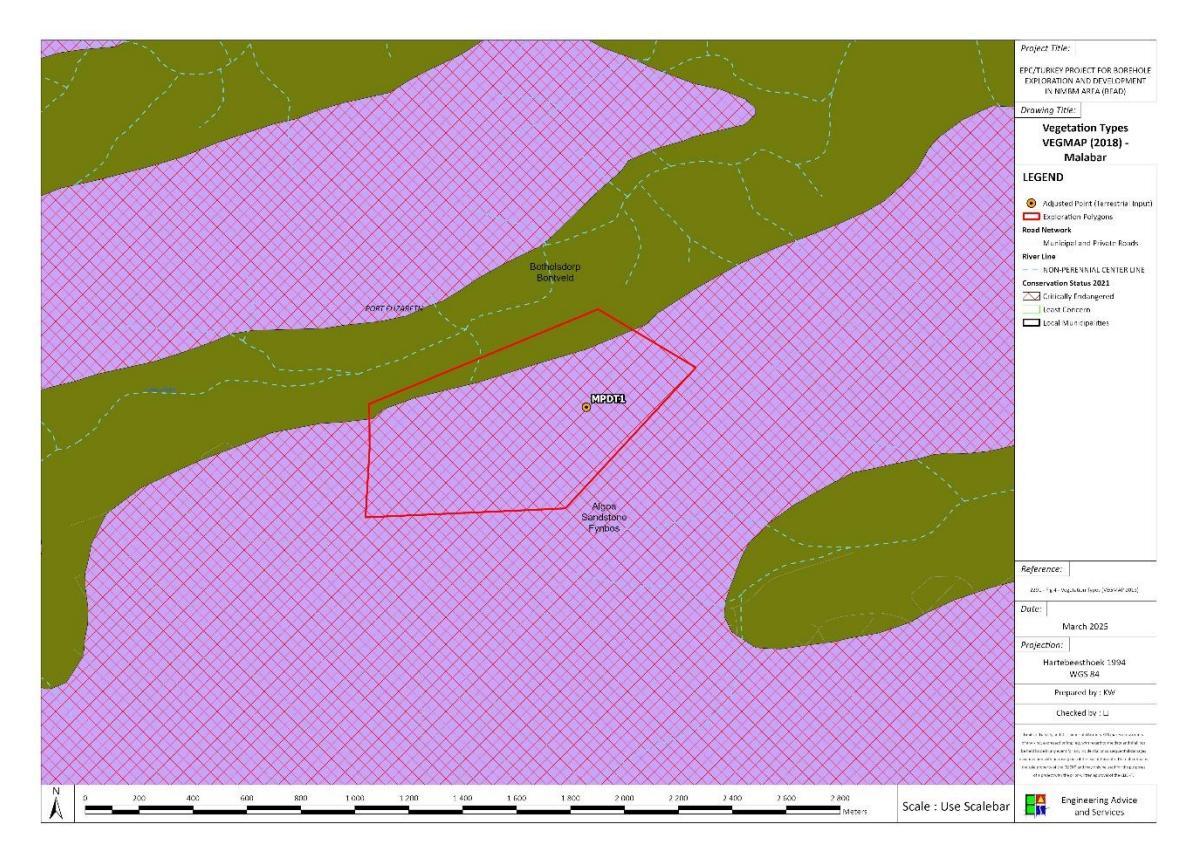
Figure 4. National VegMap (2018) – Malabar

According to the National Vegetation Map of Southern Africa (2018), the vegetation cover of the Malabar site comprises Algoa Sandstone Fynbos (Critically Endangered), and Bethelsdorp Bontveld (Least Concern) (see **Figure 4**). Localised encroachment by the alien shrub *Acacia saligna* was noted on site.

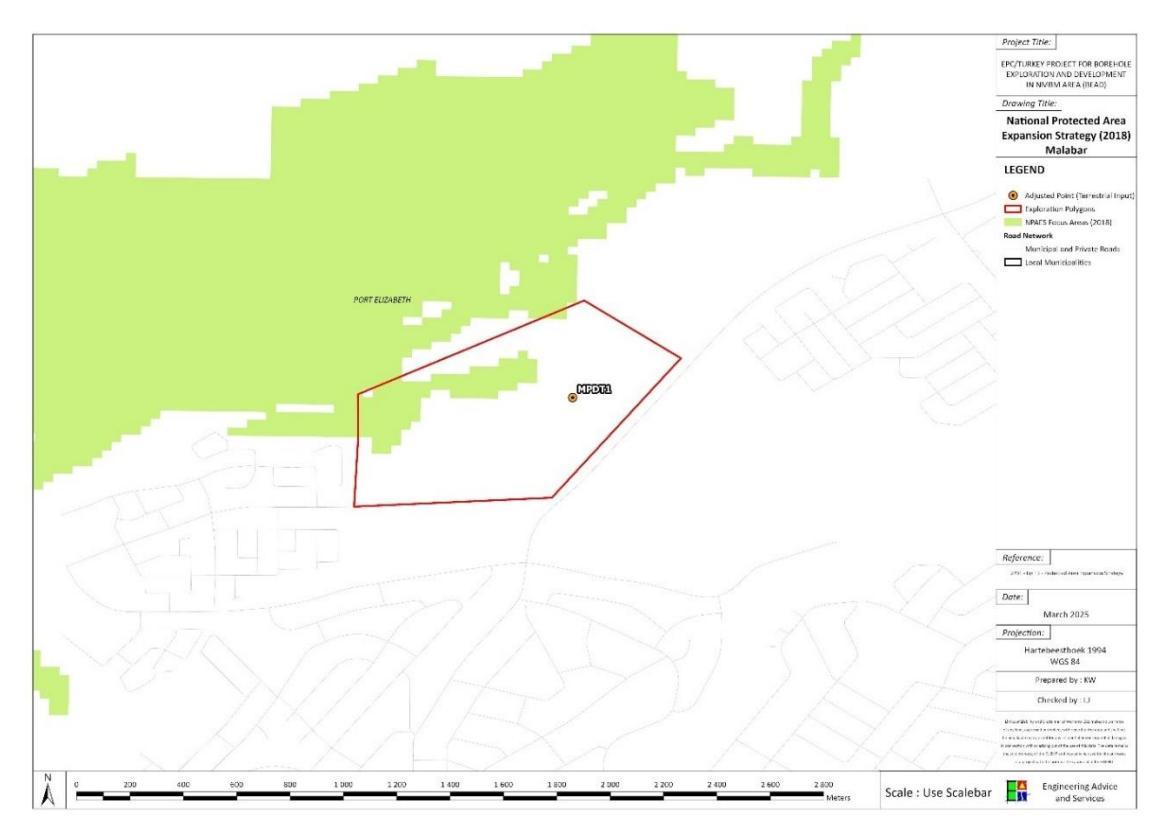
Figure 5. National Protected Area Expansion Strategy (NPAES) - Malabar

The STEP Vegetation types and Corridors indicate that Algoa Grassy Fynbos and Bethelsdorp Bontveld are present on the site which all have a conservation status of Vulnerable. The vegetation present within the site does indicate features characteristic of the fynbos which is designated to the area. According to the DFFE National Screening Tool, the proposed site falls within the National Protected Areas Expansion Strategy (NPAES) (refer to

Figure 5). There are no Nature Reserves within 5 km of the site and no National Parks or World Heritage Sites within 10 km of the site.

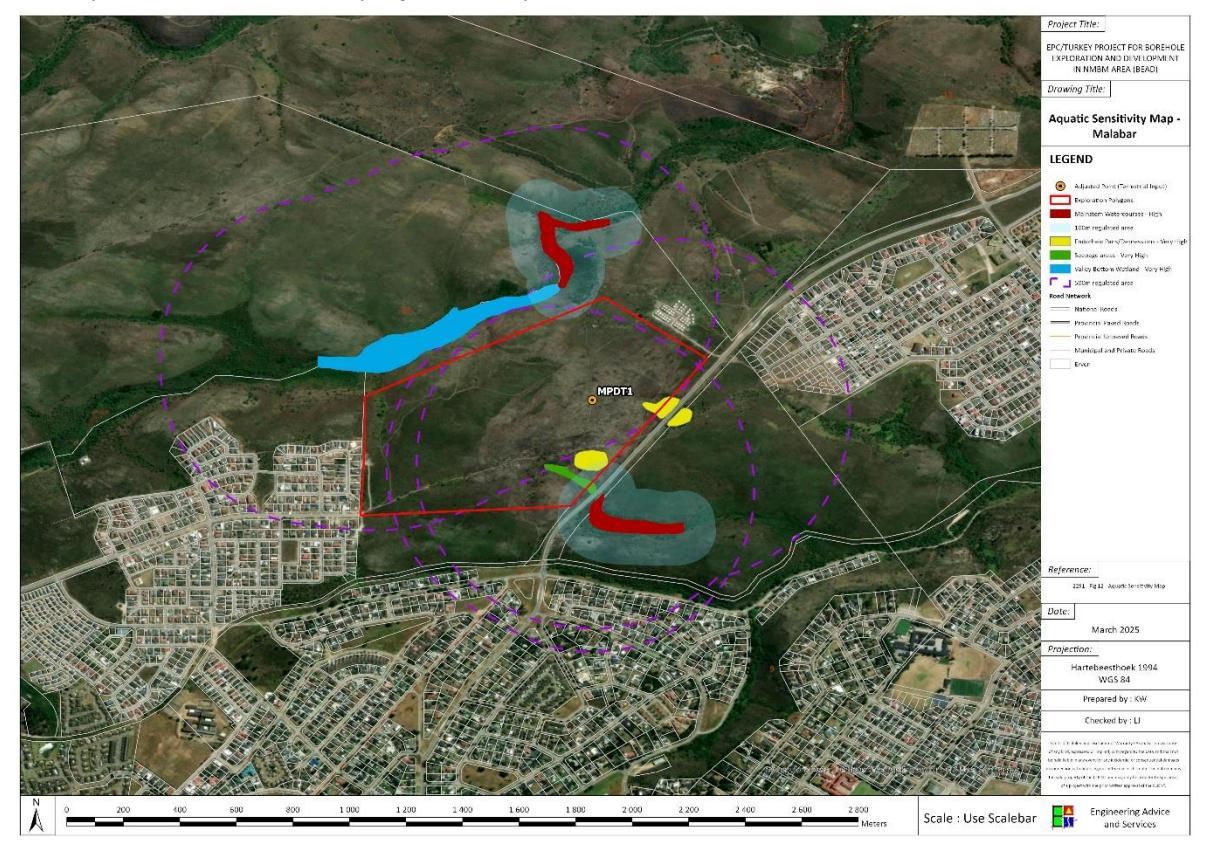
Figure 6. Results of the specialist assessment and the confirmed sensitivity of the observed aquatic systems within the Malabar site

According to the Aquatic Compliance statement (Colloty, 2025), the proposed site falls within 100m of two mainstream watercourses and 500m of the following delineated freshwater systems:

- valley bottom,
- seepage areas, and
- endorheic pans.

The current state of these systems includes dense alien vegetation, illegal dumping, vehicle tracks, and grazing. These systems are rated with very high sensitivity.

The proposed project (Phase 1) is therefore supported in terms of aquatic biodiversity considerations, on the condition that all of the proposed infrastructure:

- Will remain outside of the delineated freshwater feature footprints, especially where no impacts or previous disturbances occur).
 - These systems which were mostly wetlands (as shown in the Screening Tool), must therefore be avoided by any drilling activities inclusive of access.
 - Access along existing tracks/roads (e.g. Godetia Drive) within these systems is allowable assuming that no additional road upgrades will be required.
- All works within the regulated area of a watercourse are suitably authorised under the National Water Act (No. 36 of 1998), as relevant and applicable, prior to the commencement of explorations (Applications are in process).

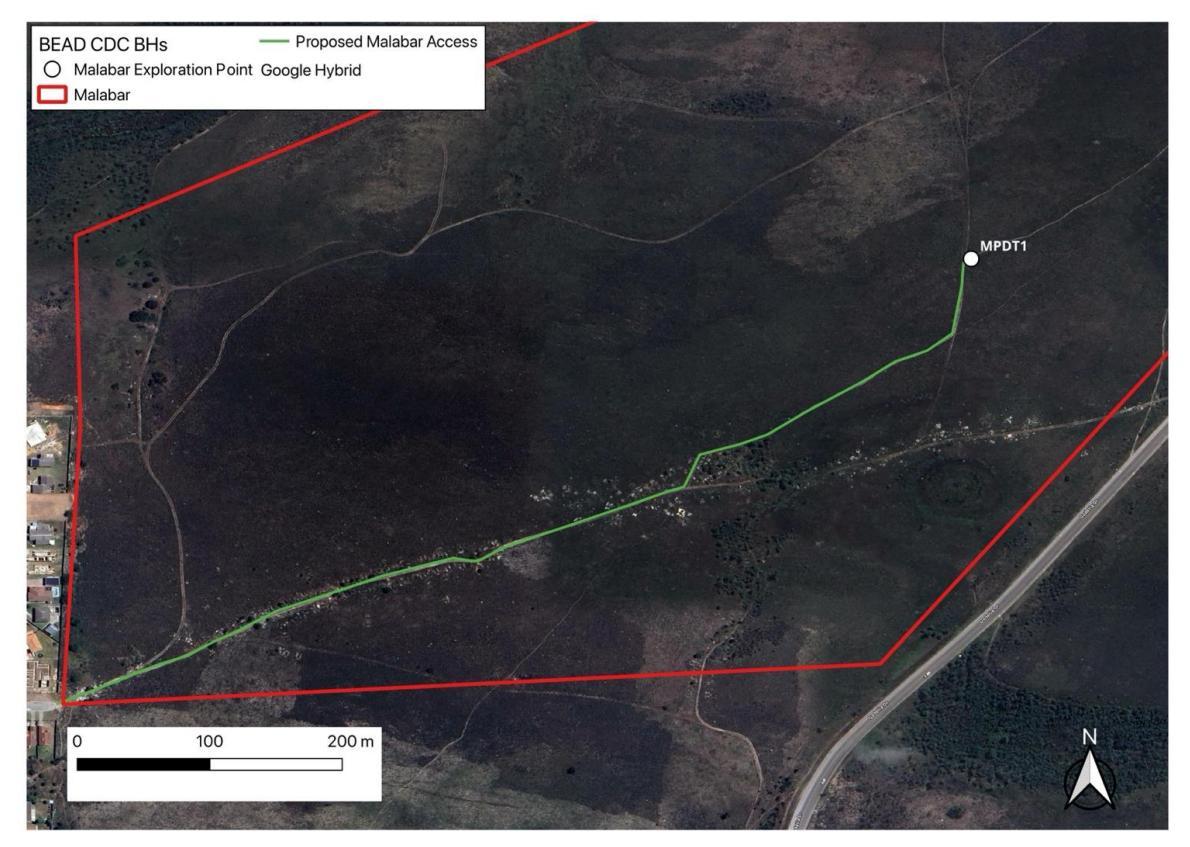
Figure 7. Proposed access route along existing track with a high degree of disturbance (illegal solid waste disposal)

The terrestrial biodiversity specialist suggested that the Malabar exploration only has one access road used due to the high degree of disturbance that already exists on the access road.
